IN Home Inspection Inc.

Property Inspection Report

123 Main St., Plymouth IN, 46563
Inspection prepared for: Sam Sample & Samantha Sample
Inspection Date: 10/14/2010 Time: 9:00 AM
Age: 10 Yrs. Size: 2200 sf
Weather: Sunny/65 F
Sample Report

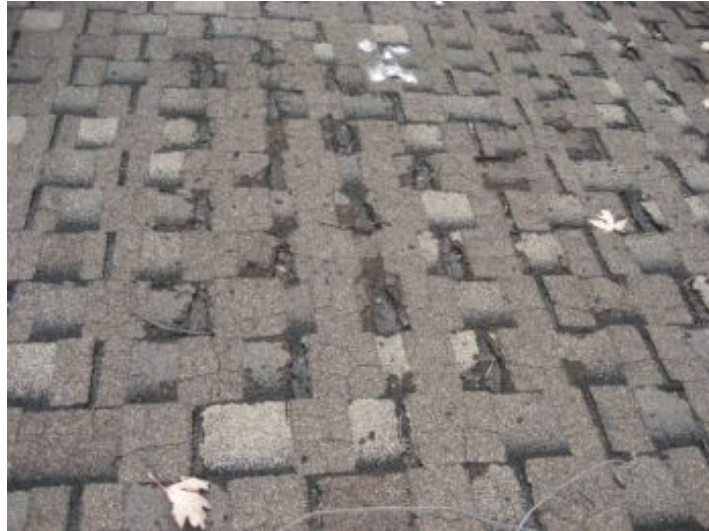
- Some shingles damaged, some curling. This roof is close to the end of it's service life. Recommend a qualified roofing contractor evaluate.
- Clean roof areas: Significant amounts of organic debris evident.

Composition shingle condition

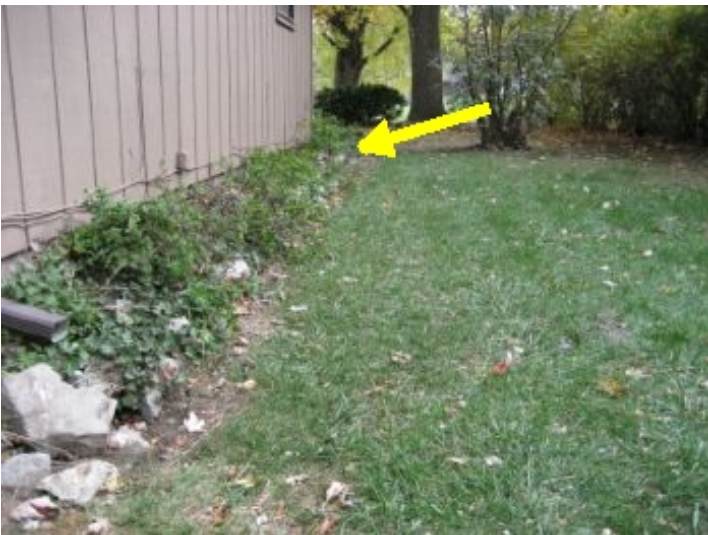
- The exterior drainage is generally away from foundation -- except where noted below.
- Siding-Soil contact or proximity. This may provide entrance of moisture or insects to siding. Recommend grading soil so there is at least 6" of space (where practical) between the siding and the soil below and checking for any damaged trim and siding materials.

Reverse Grade at rear of home

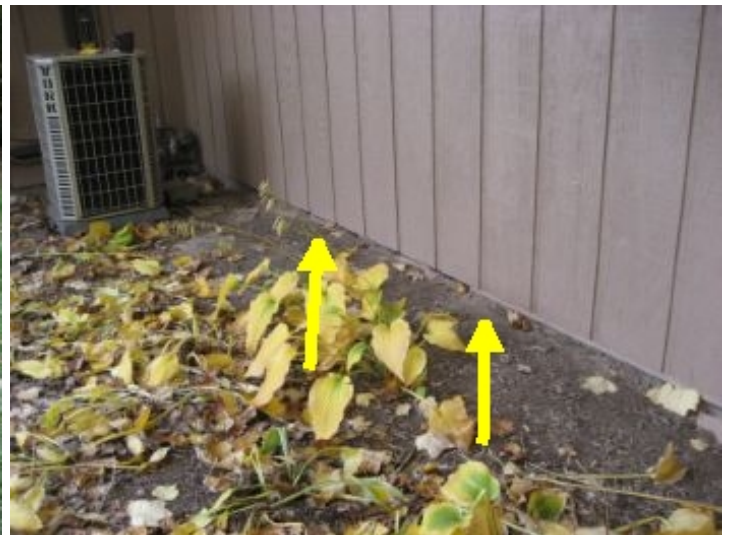
Insufficient Grade separation at Siding

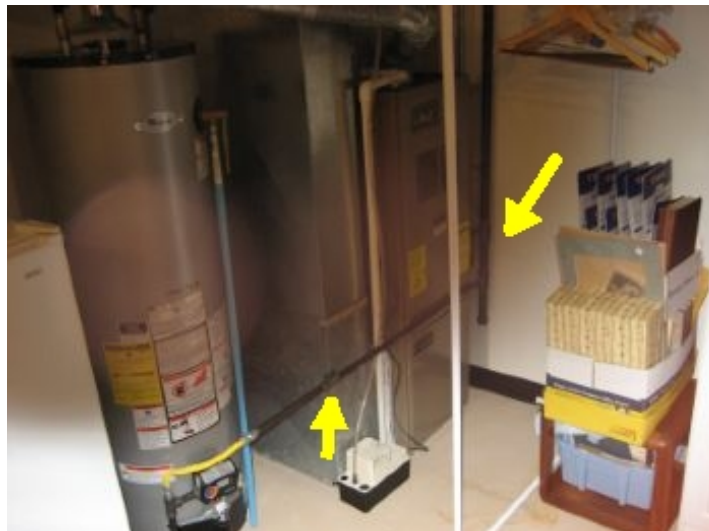
- Gas shut off valves were present and functional.

Water Heater/Furnace Gas Shut-offs

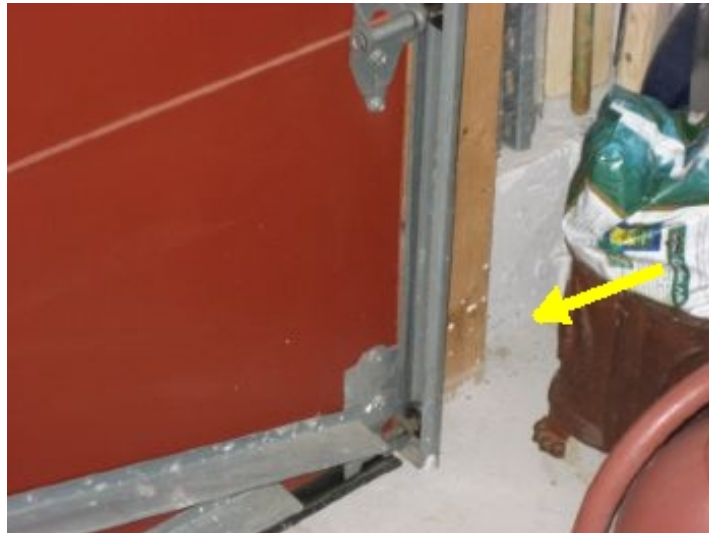
Observations:
 • No eye beam system present. This appears to be an older unit when these safety features were not included with openers. We recommend upgrading to a newer model with all safety features included.

No Door Safety Reversing System Installed

Garage		
Page 20 Item: 14	Garage Door's Reverse Status	<ul style="list-style-type: none">• No eye beam system present. This appears to be an older unit when these safety features were not included with openers. We recommend upgrading to a newer model with all safety features included.
Attic		
Page 21 Item: 1	Access	<ul style="list-style-type: none">• Insulation dams have fallen and should be re-secured to assure proper ventilation from the soffit vents.
Page 22 Item: 10	Exhaust Vent	<ul style="list-style-type: none">• Bath fans terminate in the attic.• Recommend that ducts be routed to exterior to minimize moisture an possible development of mold.

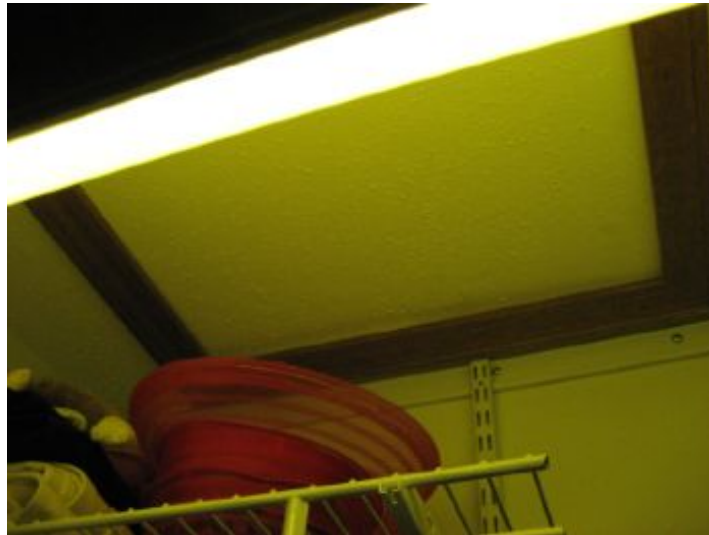
Observations:
 • Scuttle Hole located in: Bedroom Closet.
 • Limited visibility due to size of entry and shelf obstructing access.
 • Insulation dams have fallen and should be re-secured to assure proper ventilation from the soffit vents.

Scuttle Hole Access to Attic

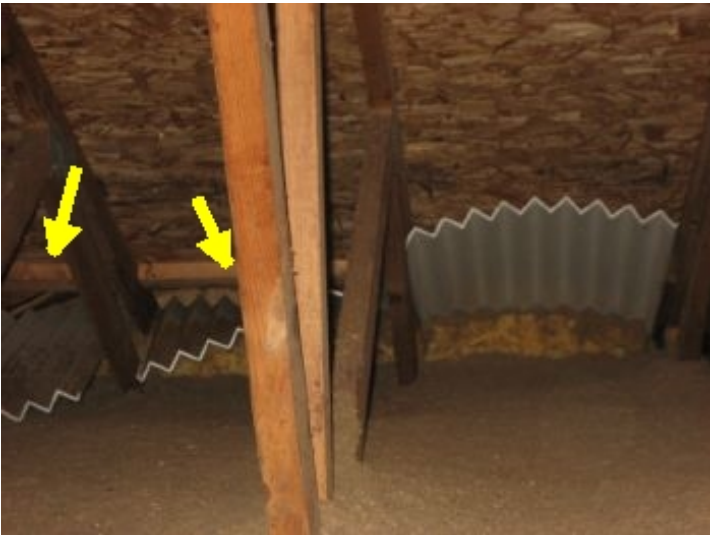
Insulation baffles have fallen at front soffit

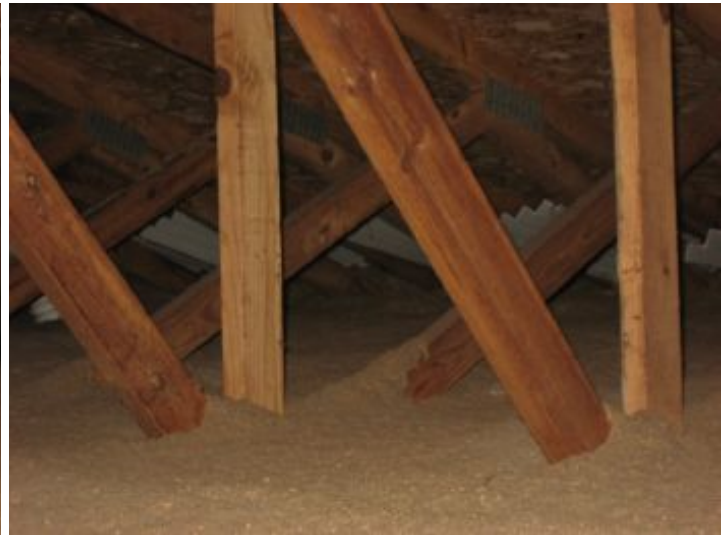
Materials: Blown in cellulose insulation noted.
 Depth: Insulation averages about 6-8 inches in depth
 Observations:
 • Insulation appears adequate.

Insulation coverage in attic

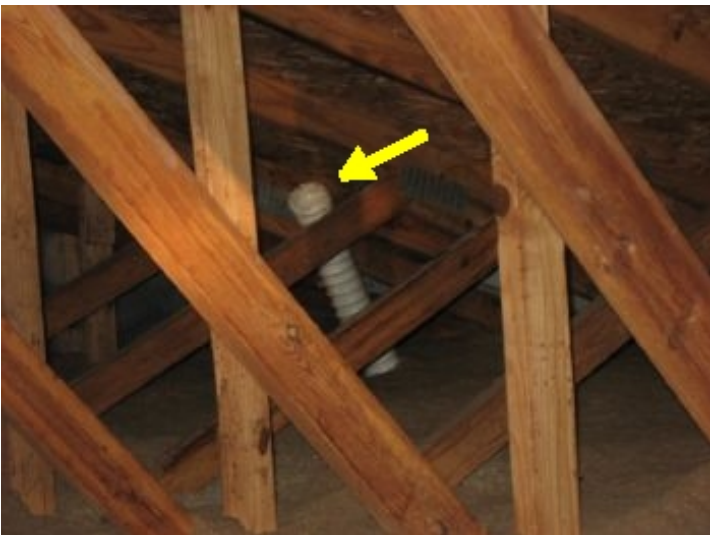
- Bath fans terminate in the attic.
- Recommend that ducts be routed to exterior to minimize moisture and possible development of mold.

Bath fan vented to attic space

Bathroom		
Page 9 Item: 8	Exhaust Fan	<ul style="list-style-type: none"> • Several of the bathroom exhaust pipes terminate in the attic. This can cause a buildup of moisture and eventually mold in the attic. Recommend directing the vent towards the exterior to allow for proper ventilation.
Page 10 Item: 16	Bath Tubs	<ul style="list-style-type: none"> • Whirlpool • Inoperable at time of inspection.

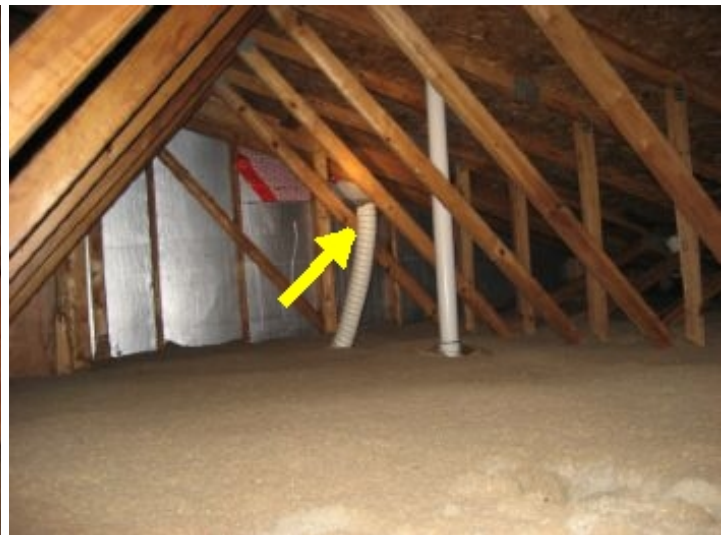
Master Bath fan vented to attic
